Radiation Countermeasures and Decontamination Efforts

Ever since the earthquake disaster, Fukushima University has been enacting a variety of measures and countermeasures to address radiation and decontamination. Amid a shortage of specialized equipment for measuring radiation, the university was able to overcome this obstacle by forming a team comprising participants from industry, academia and the government.

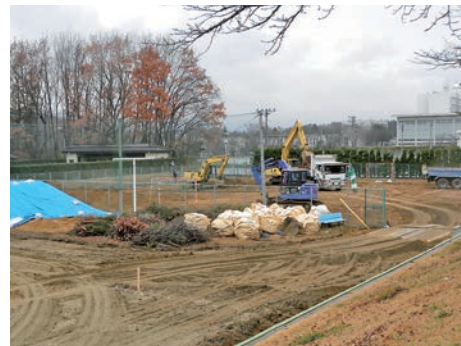
The university decided on the course of a mid- to long-term decontamination plan in October. The decontamination plan identified steps to lower radiation dose ratios in high-usage areas outdoors on campus to ensure a safe living environment on campus. Under this plan, 5cm of topsoil was removed from the soccer and rugby field, handball courts, baseball field, Japanese archery grounds and equestrian grounds in December. New

topsoil was brought in and compacted, and the removed topsoil is now permanently stored in an underground trench located under the sports field. Decontamination works began in February for the athletic field (grassed area), tennis courts, and the central square.

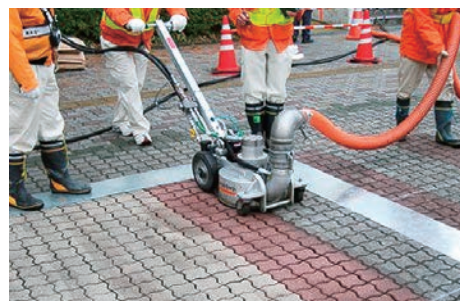
On January 28th 2012, in cooperation with the Japan Atomic Energy Agency, Fukushima University published the results of decontamination verification tests after using *J Removers* on interlocking paving within the Fukushima University Campus. This equipment cleans contaminated paving using an ultra-high pressure (up to 280 MPa) water-jet surface treatment method to pressure-wash contaminated paving, and draws water back in as it decontaminates, to remove cesium. Only sand remains as a waste product, and the water can be reused after treatment. Normal high-pressure water jet cleaners (water pressure 5 MPa) have had little effect on interlocking paving, but the *J Remover* achieved impressive results, reducing contamination levels to less than half. We expect that this technology will be used widely in future decontamination activities.
