# Radiation Countermeasures and Decontamination Efforts

Ever since the earthquake disaster, Fukushima University has been enacting a variety of measures and countermeasures to address radiation and decontamination. Amid a shortage of specialized equipment for measuring radiation, the university was able to overcome this obstacle by forming a team comprising participants from industry, academia and the government.

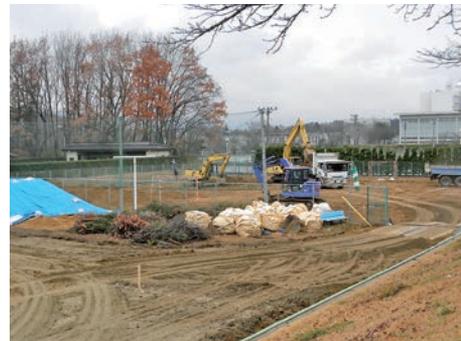
The university decided on the course of a mid- to long-term decontamination plan in October. The decontamination plan identified steps to lower radiation dose ratios in high-usage areas outdoors on campus to ensure a safe living environment on campus. Under this plan, 5cm of topsoil was removed from the soccer and rugby field, handball courts, baseball field, Japanese archery grounds and equestrian grounds in December. New

topsoil was brought in and compacted, and the removed topsoil is now permanently stored in an underground trench located under the sports field. Decontamination works began in February for the athletic field (grassed area), tennis courts, and the central square.

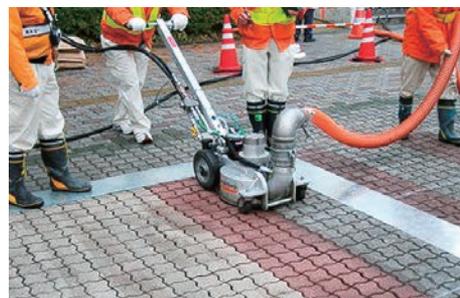
On January 28th 2012, in cooperation with the Japan Atomic Energy Agency, Fukushima University published the results of decontamination verification tests after using *J Removers* on interlocking paving within the Fukushima University Campus. This equipment cleans contaminated paving using an ultra-high pressure (up to 280 MPa) water-jet surface treatment method to pressure-wash contaminated paving, and draws water back in as it decontaminates, to remove cesium. Only sand remains as a waste product, and the water can be reused after treatment. Normal high-pressure water jet cleaners (water pressure 5 MPa) have had little effect on interlocking paving, but the *J Remover* achieved impressive results, reducing contamination levels to less than half. We expect that this technology will be used widely in future decontamination activities.
